LCDOT WILSON & NIPPERSINK INTERSECTION WIDENING

SENSITIVE OUTFALLS & MANAGING EROSION

WILSON RD & NIPPERSINK RD INTERSECTION WIDENING (GRANT TOWNSHIP & ROUND LAKE)

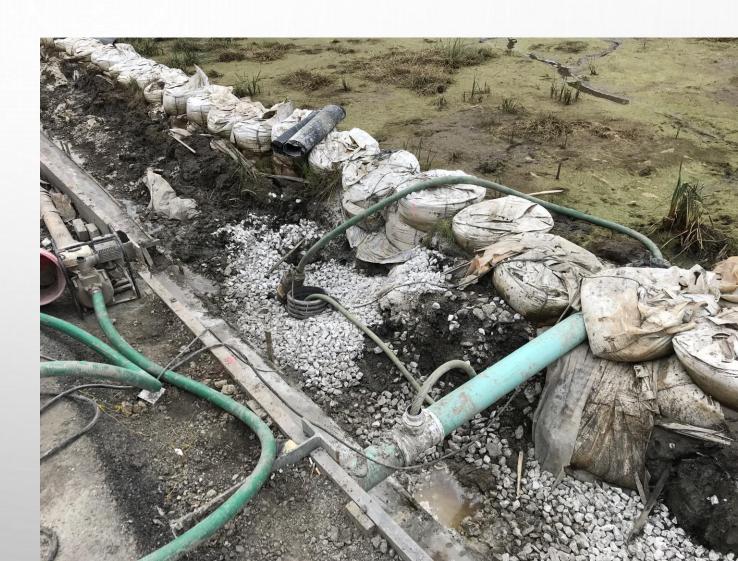
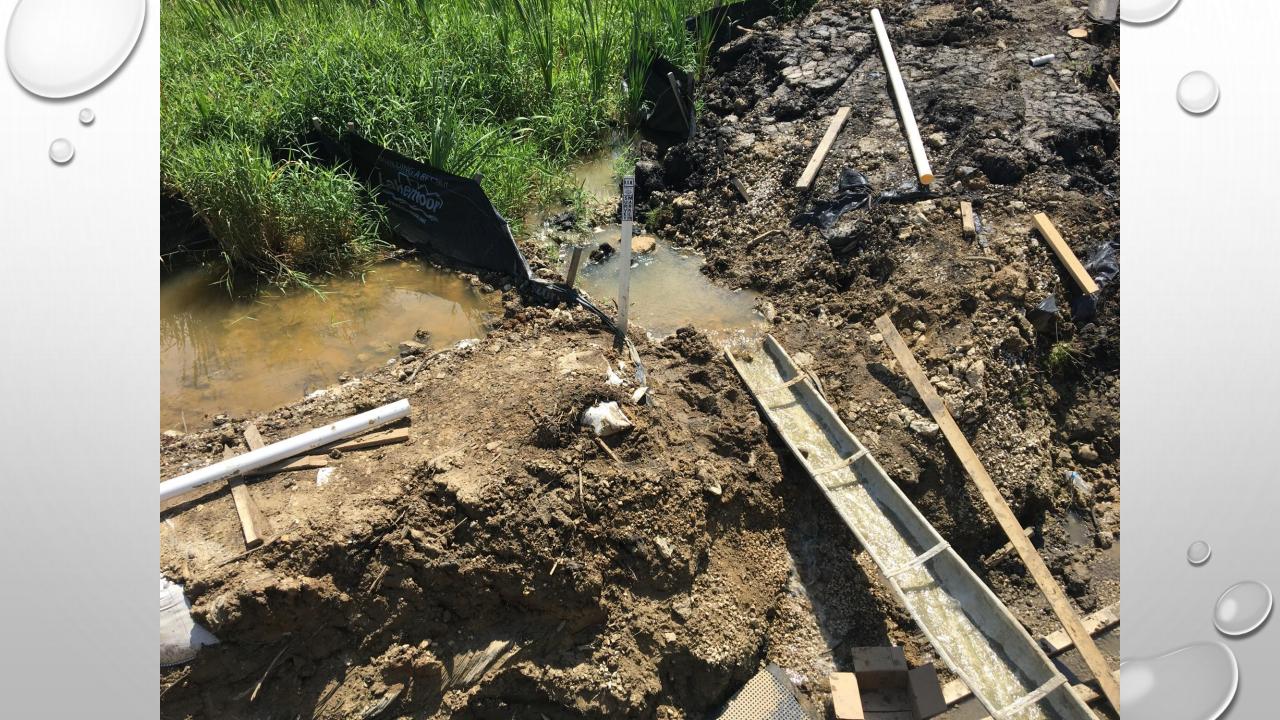
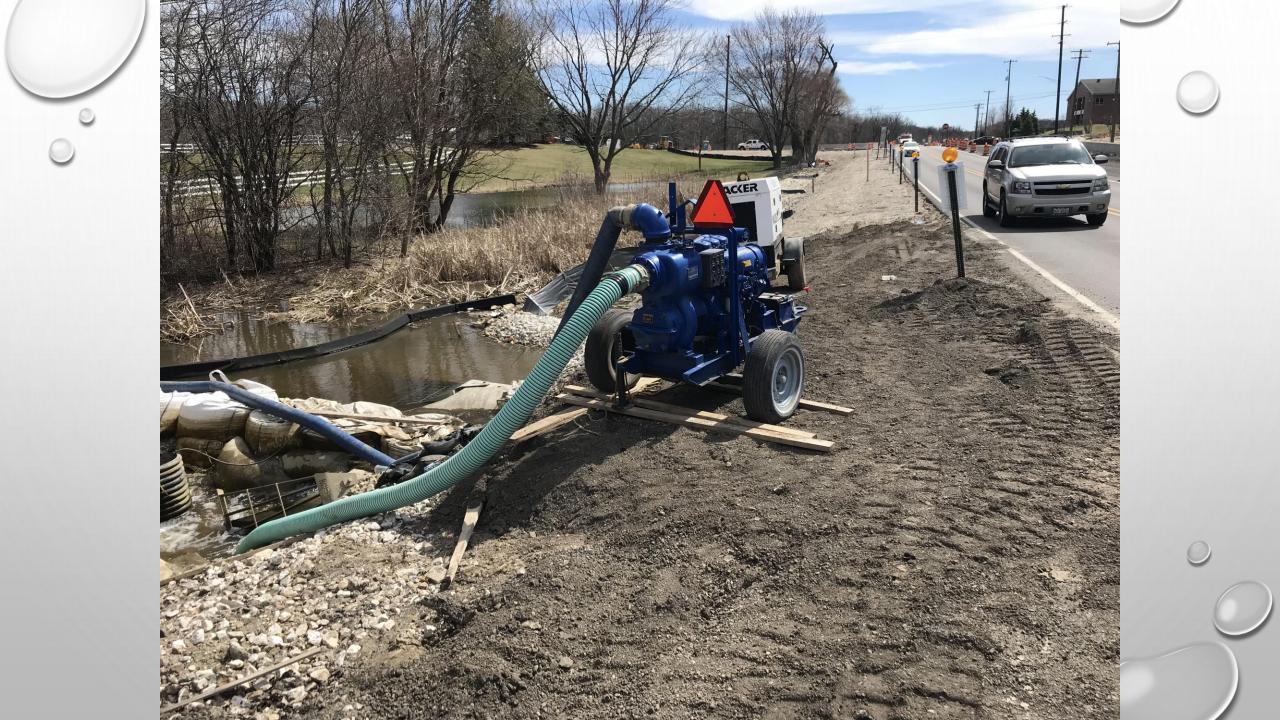
- THROUGHOUT THE PROJECT THERE WERE MANY VARIOUS DEWATERING SETUPS AT LOCATIONS
- IT WAS IMPORTANT THAT WE MAINTAINED NATURAL DRAINAGE PATTERNS WITH TEMPORARY EXTENSIONS OR BYPASSES
- AT TIMES THERE WERE OVER 10 PUMPS ONSITE RUNNING

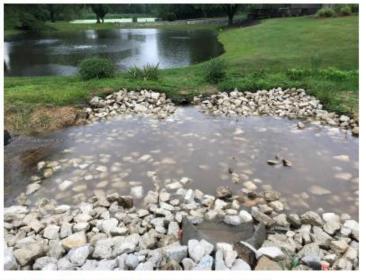
27+55 LT During storm on 7/18/19, clear discharge water to pond

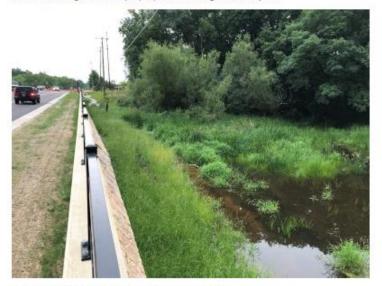
Backside of Northwall, water clear and grass growing

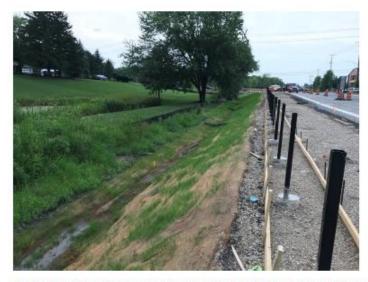
151+00 RT looking south at grass growing on slop and plastic permeable berms in place
